PROPOSED COMMONWEALTH  
RADIOACTIVE WASTE MANAGEMENT  
FACILITY, NORTHERN TERRITORY

# Geology and Geotechnical Investigation Report

13 March 2009

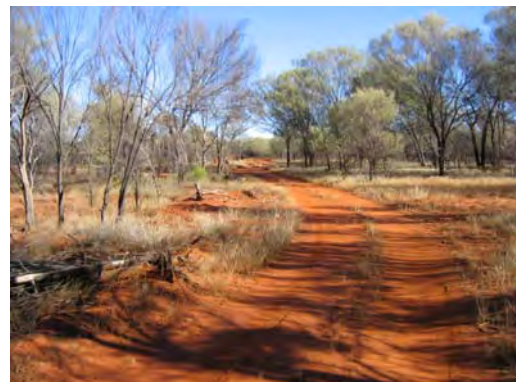
**PHOTOGRAPH G2.1**  
**Typical surface layout and vegetation at**  
**Mount Everard site**

Vegetation within the site includes native grasses and shrubs as well as weeds with some areas being cleared of all vegetation to accommodate some of the facilities infrastructure (Photograph G2.1).

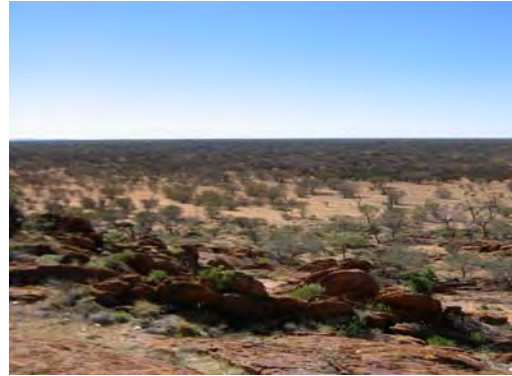
**PHOTOGRAPH G2.2**  
**Typical surface layout and vegetation**  
**at Harts Range site**

The site is generally flat with elevations within the site's boundaries ranging from 652 m AHD to 660 m AHD. Surface drainage tends to migrate towards Annamurra Creek to the west and Ongeva Creek to the east. A minor drainage channel was noted trending approximately north-south in the central northern part of the investigated site. The channel was dry at the time of the investigations.

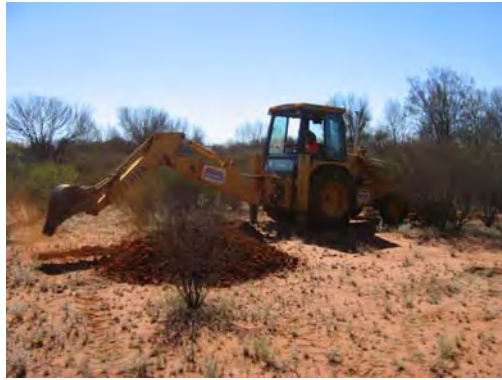
**PHOTOGRAPH G4.1**  
John Deere 315D backhoe used to excavated test pits at Mount Everard and Harts Range site (photographed at Harts Range)

Both backhoes and the excavator were in generally good condition and equipped with 450 mm toothed buckets. In addition to the test pits the machines were also used to excavate sump pits used during the diamond core drilling program at Mount Everard, Harts Range and Fishers Ridge. The sumps pits at Muckaty Station were excavated using a front end loader from Philips Earthmoving.

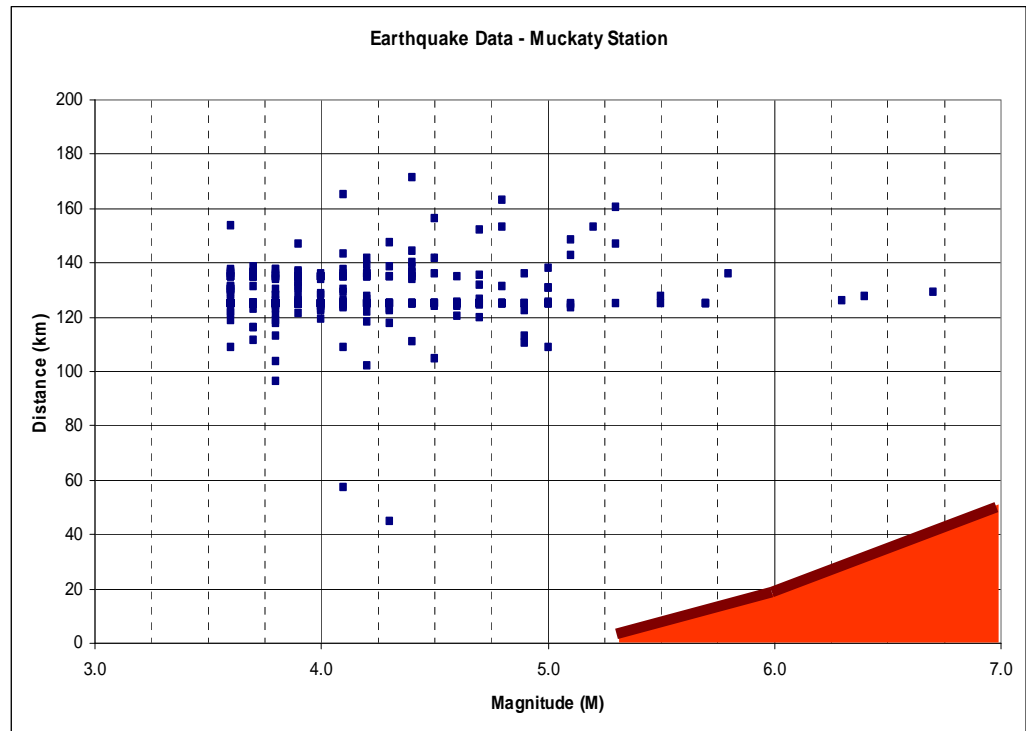
**FIGURE G6.11**  
 Earthquake data within 200 km of Muckaty Station

Figure G6.11 below displays the recorded seismic events within a 200 km radius of Muckaty Station. The shaded zone indicates the maximum epicentre distance and minimum Richter Scale magnitude required for a seismic event to cause minimum site acceleration of 0.10 g or greater at Muckaty Station (based on Table G6.1 limits). It is

apparent that no recorded seismic events to date have caused greater than 0.10 g acceleration at Muckaty Station.

Given an Modified Mercalli Scale Intensity rating of *IV* (average peak ground acceleration 0.007–0.015 g), the likely effects from any earthquake located south-west of Tennant Creek on Muckaty Station may be limited to vibrations like a passing truck, hanging objects swaying, windows and doors rattling and crockery clashes (MM Scale 1956 Version, Hunt 2007).

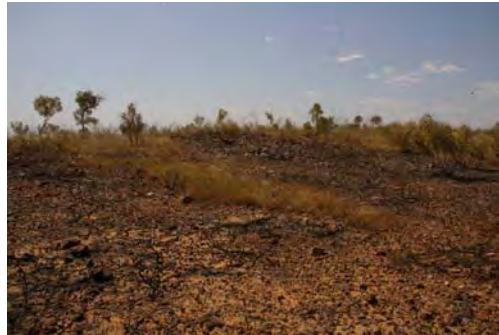
**PHOTOGRAPH G7.10**  
**Low rocky ridges to west of Province 1,**  
**Muckaty Station**

Rock outcrops in low lying ridges (Photograph G7.10) surround Province 1 which is mainly covered by loose, dry sands and silty sands with some basal gravels above bedrock at shallow depths (<5 m, Photograph G7.11).

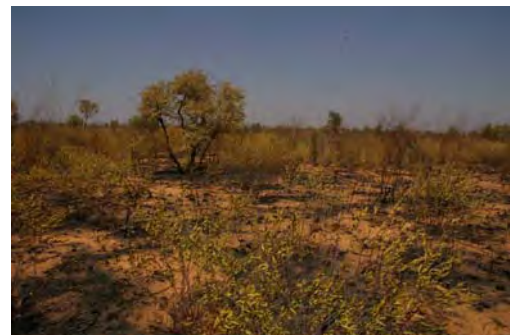
**PHOTOGRAPH G7.12**  
**Sandy plain, Province 2, Muckaty Station**

Province 2 is a very prominent sand plain (Photograph G7.12) that runs WNW-ESE which is bound by low lying mud plains to the north and the Hayward Creek Formation rocky ridges to the south.

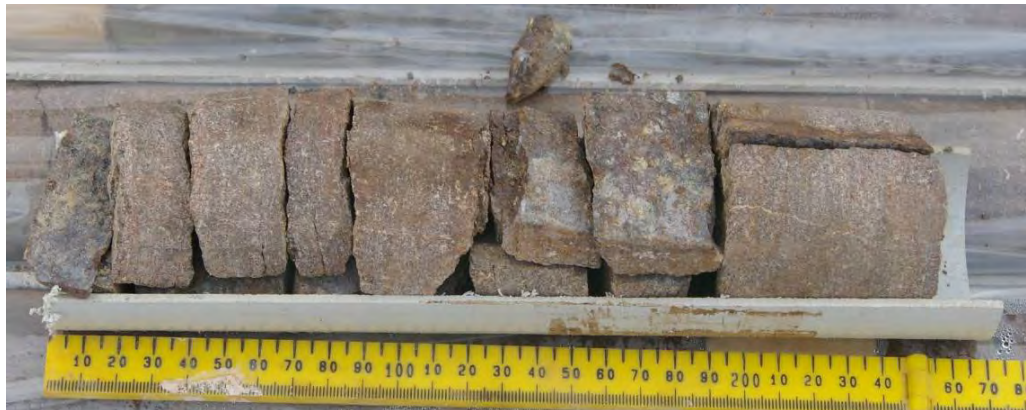
**PHOTOGRAPH G7.13**  
**Recovered core of slightly weathered, fractured basalt, Province 2, Muckaty Station**

underlying the sand plains which would have its western edge between boreholes MSBH02 and MSBH03.

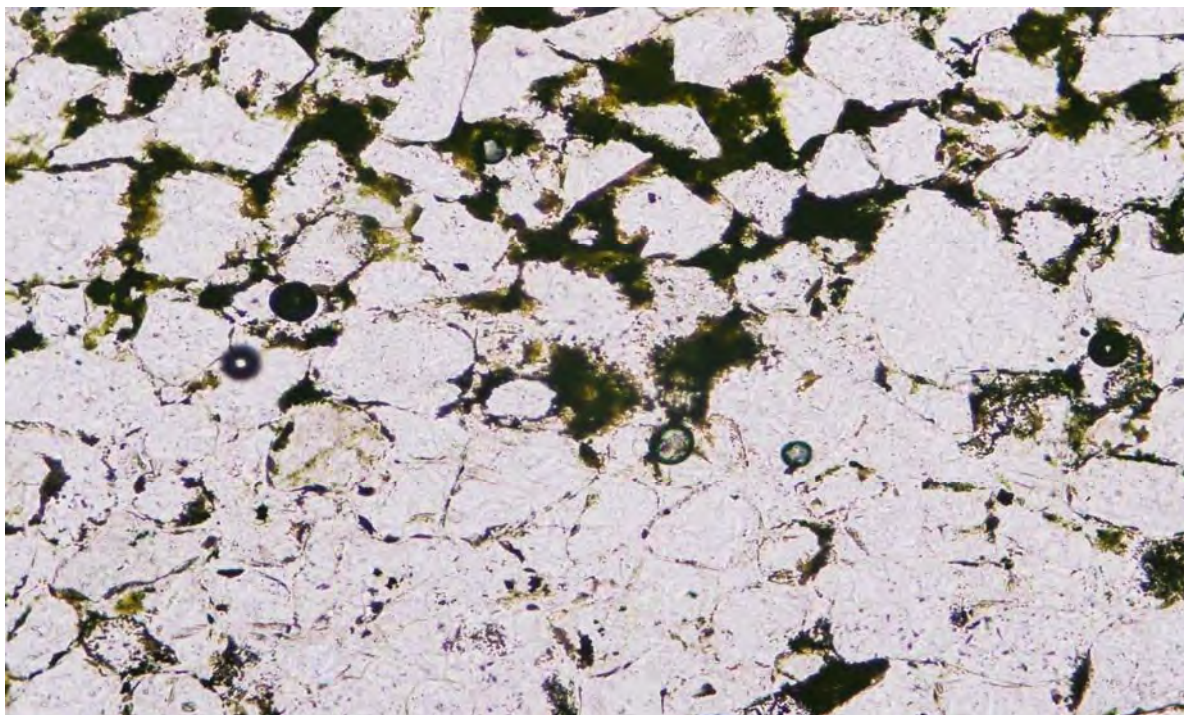
**Fig 5**

Up to 15% of the whole rock aggregate however consists of evenly scattered grains of (optically) indefinite clay-sericite which are selectively oxidised/stained by pale yellowish brown limonite, slightly more abundant in some layers/thin beds than in others. These appear to represent selectively altered/weathered original detrital grains of feldspar and/or of lithic grains originally deposited with the quartz grains. [XRD reports this clay-sericite as kaolinite.] This may constitute a minor whole rock weakness (very incipient friable character) to this otherwise very coherent rock.

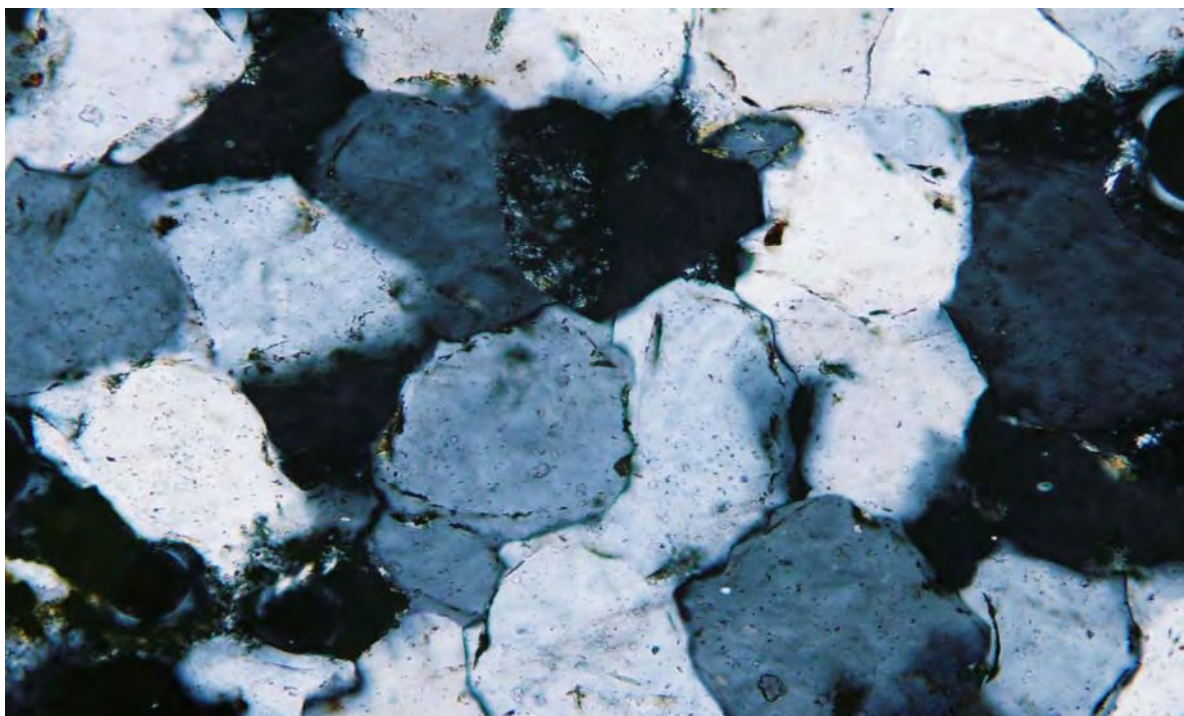
**Fig 6**

TS. OL (x100). Medium grained sandstone as described, somewhat loose-packed aggregate of subangular quartz grains, dark (opaque) intergranular limonite more extensive in some area than in others.

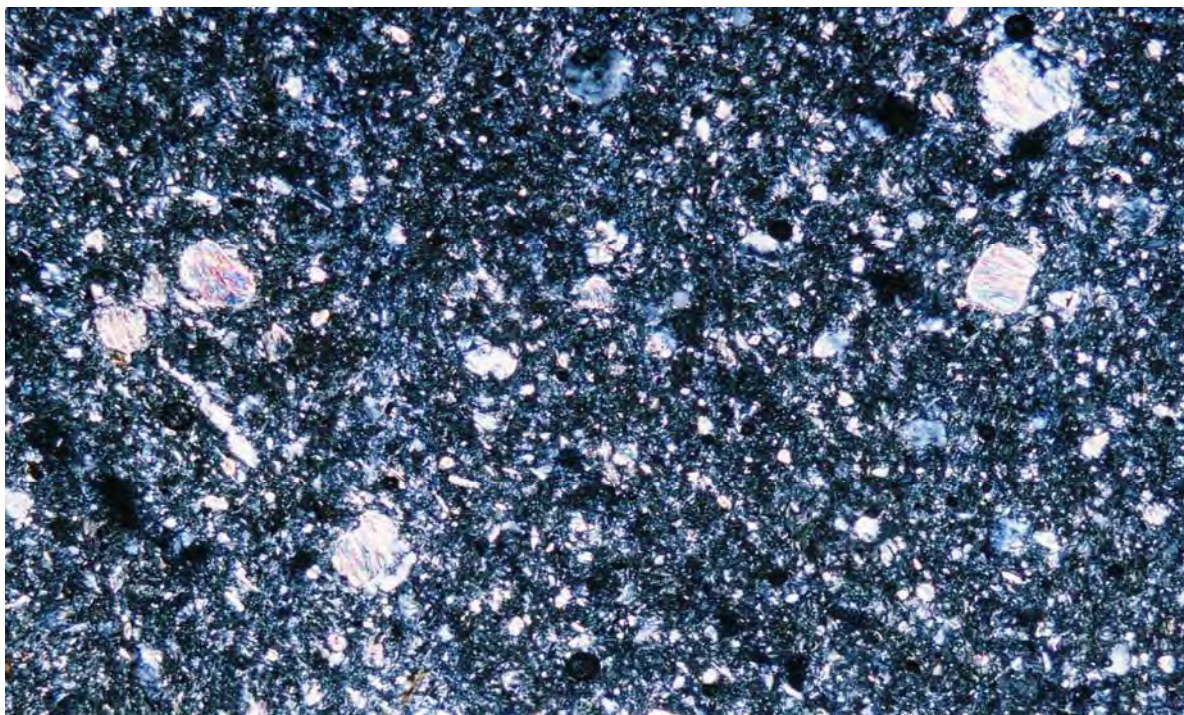
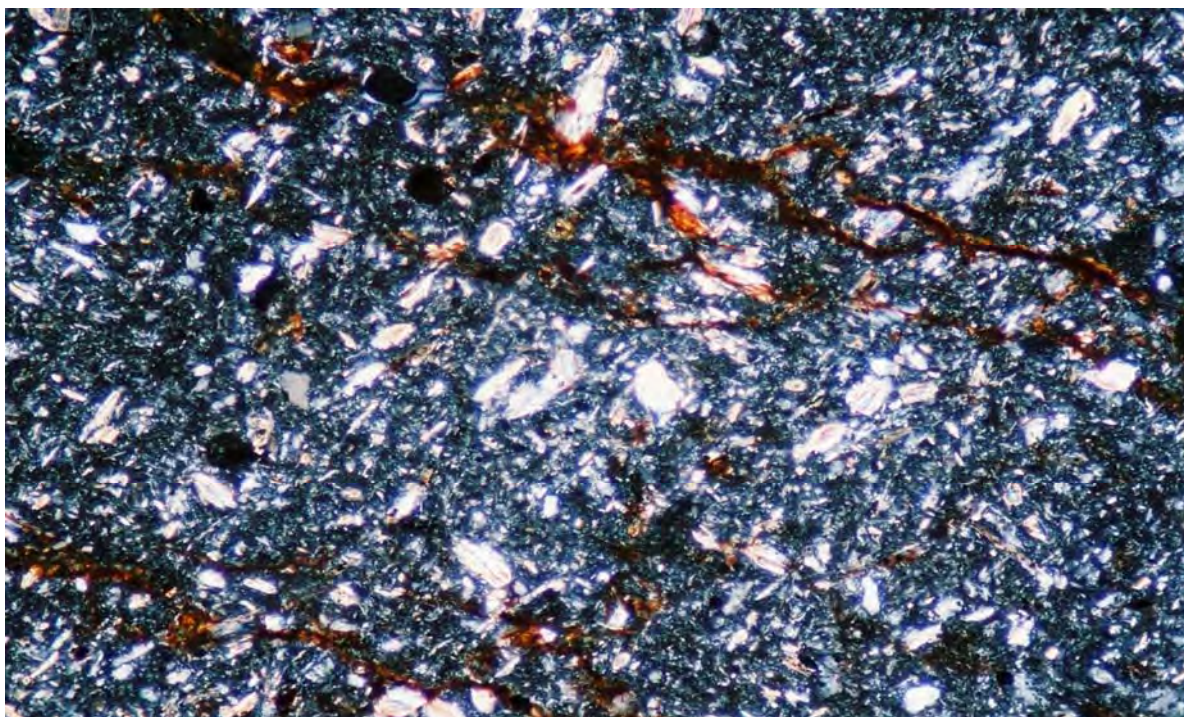
**Figs 9 & 10**

The above indicates that this rock is basically a “mudstone” with apparent weak bedding and sparse dispersed silt. It is cut by random thread-like microfissures/networks which are selectively limonite-stained.

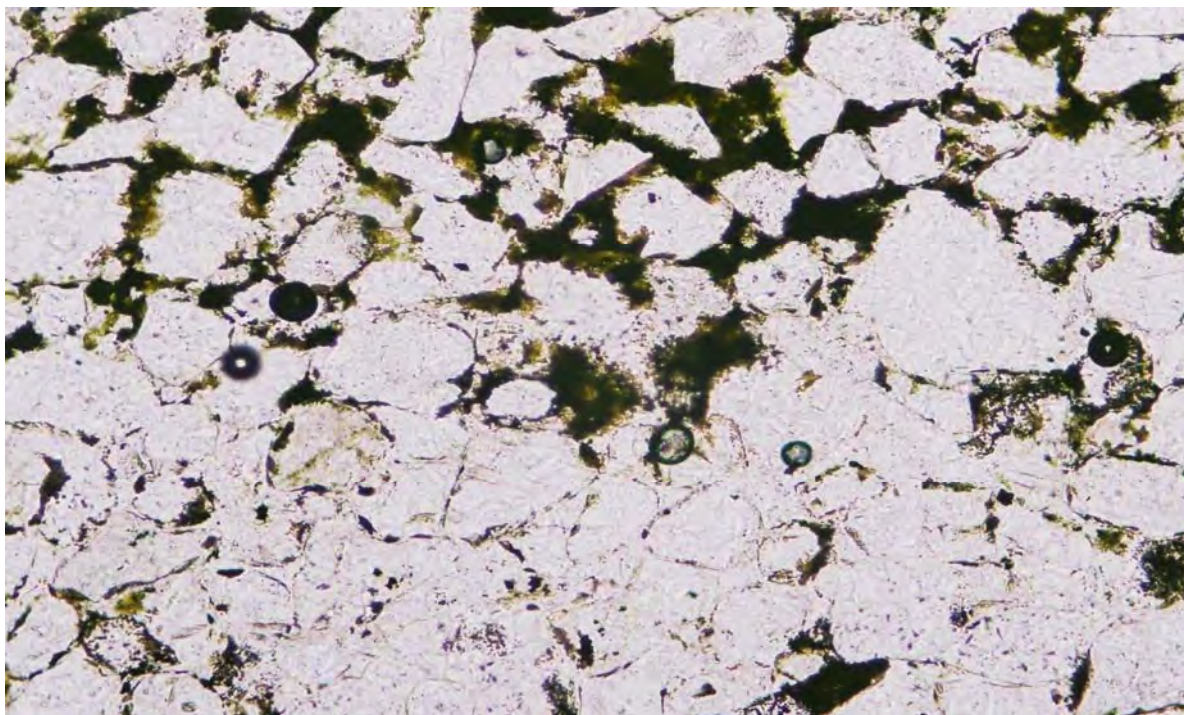
**Fig 5**

Up to 15% of the whole rock aggregate however consists of evenly scattered grains of (optically) indefinite clay-sericite which are selectively oxidised/stained by pale yellowish brown limonite, slightly more abundant in some layers/thin beds than in others. These appear to represent selectively altered/weathered original detrital grains of feldspar and/or of lithic grains originally deposited with the quartz grains. [XRD reports this clay-sericite as kaolinite.] This may constitute a minor whole rock weakness (very incipient friable character) to this otherwise very coherent rock.

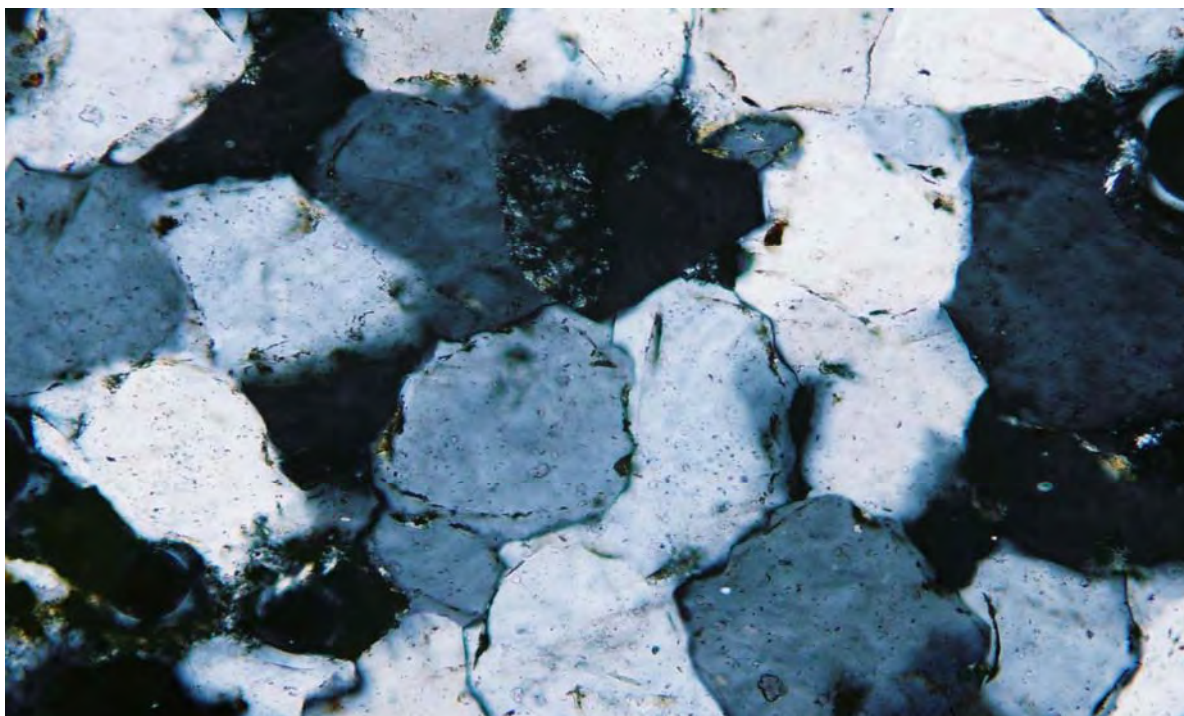
**Fig 6**

TS. OL (x100). Medium grained sandstone as described, somewhat loose-packed aggregate of subangular quartz grains, dark (opaque) intergranular limonite more extensive in some area than in others.
